Black Dust in an Office

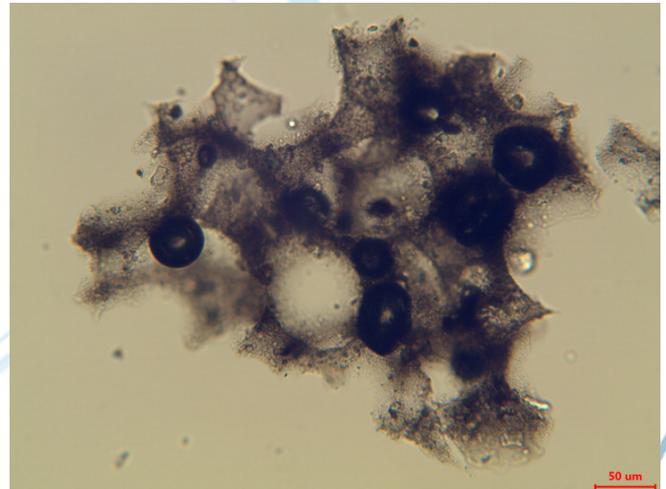
PLM Image

Examining the sample with a polarized light microscope (PLM), it was darker and coarser than expected for a mold sample. The dust appeared to be a closed cell, synthetic blown foam material, and all from the same source. The black color was likely due to pigment particles added to color the foam.

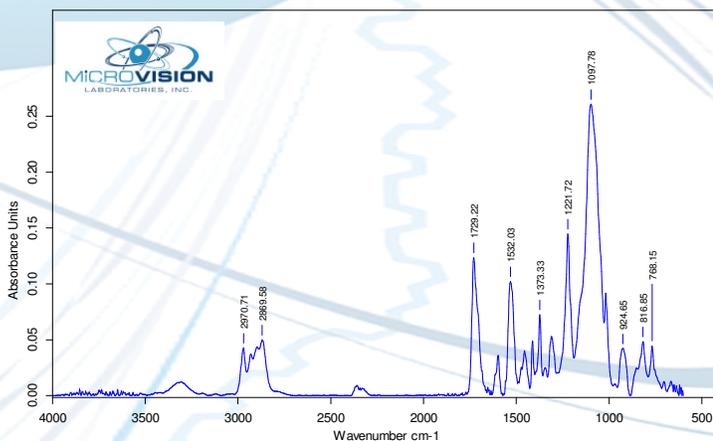
FTIR Spectrum of Urethane Acetate Foam

Fourier Transform Infra-Red spectroscopy was performed on the foam particles. The spectrum showed a mixture of spectral features, associated with vinyl acetates, polyurethane, and cellulose or other sugar-like polymers. Based on these features, a common urethane acetate foam was determined as the likely source material.
